Cultural Landscape: Rebuilding after Decay International Conference

PROCEEDINGS

Kerpic'16

17-18 December 2016 Organized by Istanbul Aydın University Kerpic Network

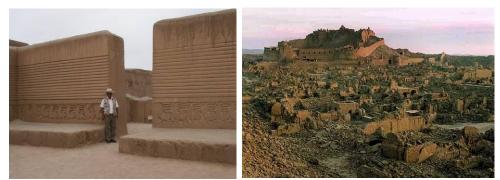
Figure 2. Ancient earthen citadels of Chan-Chan, in Peru (left) and Arg-e Bam, in Iran (Photo credit: Cultural Heritage News, right)

Many historical earthen constructions have been able to withstand severe earthquakes because of their massiveness and regular configuration. For example, the Chan-Chan archeological site (1200 CE), located on the coast of Peru, is considered to be one of the world's largest mud citadels, and has survived many severe earthquakes during the past 600 years. Decorated boundary earthen walls, some of them up to 9 m tall and 3 m wide at the base, can be found in the citadel. Many long and slender walls without buttresses are still standing (Figure 2, left). Massiveness is not, however, a guarantee for earthquake endurance. For instance, the 2003 Bam earthquake in Iran destroyed several thousands of poorly made adobe houses and important ancient historical monuments such as the earthen citadel of Arg-e Bam (500 BCE; Figure 2, right). The architectural design of the Bam citadel and surroundings includes upper thin walls standing over thick base walls, irregular plan configurations, and high wall densities. It seems that slender walls have collapsed, impacting adjacent walls and constructions, causing total destruction of the site, in spite of its massiveness.

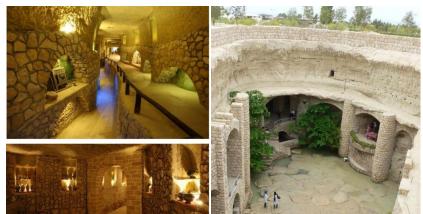
Figure 7. Kish Qanat, kish [15, 16]

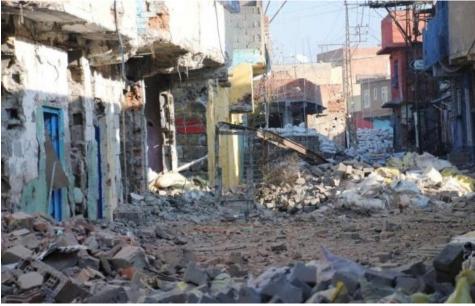
Figure 13. Diyarbakır Sur, after conflicts [32]

for World Heritage List continued and they were included in 2015. Unfortunately, due to recent conflicts in the area, cultural landscape has been damaged (Figures 12, 13) and several initiatives have been taken to reconstruct the area. Diyarbakır Metropolitan Municipality's Cultural Heritage Damage Assessment Report on Sur, dated May 30, 2016, demonstrates severe destruction resulting from conflict [28] and in return government promises 4 million TL investment for reconstruction of Sur district of preservation of 1000 historical artifacts and rebuild of 8000 houses in compliance with cultural landscape [29].

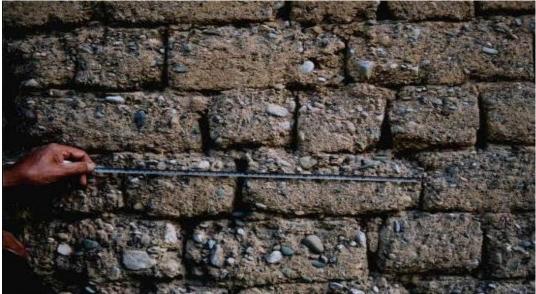
Figure 8. A view of a wall made of adobe material which consists of big agregate [22]

Hay and other vegetation used in the making of adobe is a source of nutrition for ants and other life forms. Reptiles, rodents, insects, bacteria, fungi and vegetation species that live in the soil environment play active roles in the degradation of adobe structures. For instance, life forms that feed off plant roots in the adobe structure cause the weakening, breakdown and erosion of the adobe by opening channels to reach the roots of these plants (Figure 8, 9) [20, 21].

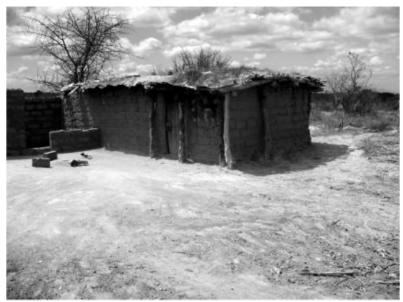
Figure 9. Plants growing up in an adobe house causes biological decays. Adobe constructed building in Dodoma, Tanzania [23]

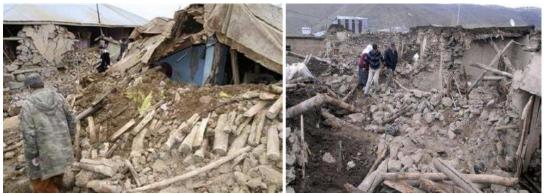
Figure 11. Destroyed adobe buildings in Elazığ earthquake [27]

As is seen in Figure 11, some of the adobe structures and the masonry with rubble and earthen mortar stone wall experienced major damage in an earthquake that struck Elazığ on 8 March 2010. When in fact, had a suitable design and project with proper production techniques and production materials been inplemented, these adobe structures would have been sufficiently resistant against such an earthquake (Figure 11) [27].

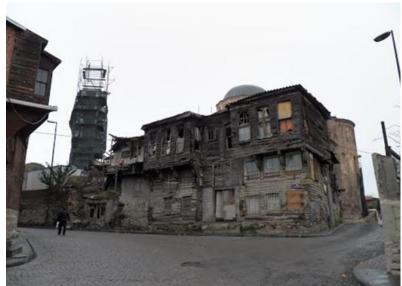
Figure 10. Decay in Zeyrek [8]

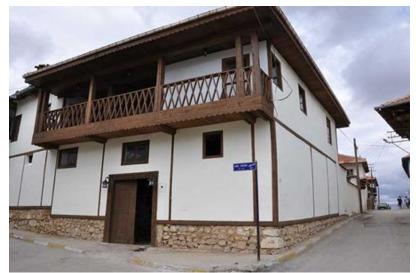
Figure 7. An adobe house with a rock foundation on Engin Sokak in the Kaş District of Yalvaç, Isparta [15]

In order to protect walls from water intrusion in adobe structures, one of the traditional construction techniques in our country is to erect the adobe structure over a stone foundation, as it is considered to be one of the healthiest methods available. The adobe homes in Yalvaç, Isparta are great examples of this construction method (Figures 7,8). Of course, putting up stone walls today comes at a high cost and necessitates more labour. For this reason, applying a reinforced concrete foundation on adobe structures will protect the structure wall against humidity.
