Rubberdam Clamp Ingestion During Root Canal Treatment: A Case Report

Case Report

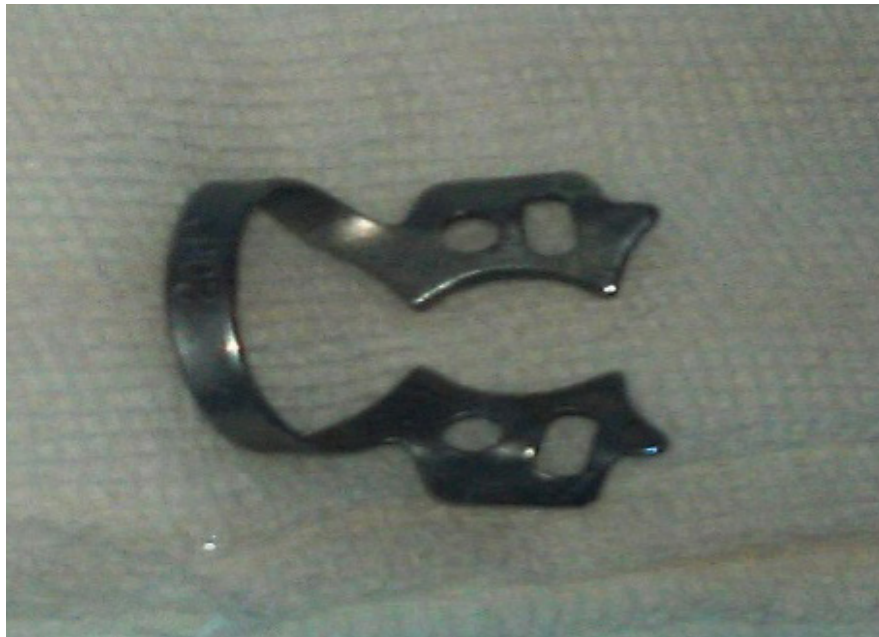
Figure 2. Ingested rubber dam clamp

The next morning, rubber dam clamp was taken out under general anesthesia via esophagoscope (Fig.2). It was precisely located laterally in the first constriction of esophagus. Post-operative findings were normal, but the patient was fed parenterally for 2 days.

A dentist must carefully follow every step of rubber dam placement procedure. Improper clamp selection or careless placement of the clamp may result in serious complications as in our case.
